LABORATORY REPORT

Report No.: 10100547-002-v1
Date Received: 10/15/2010
Date Reported: 11/4/2010
P.O. No.: Verbal VB

Sample Description: Implant with an abutment attached

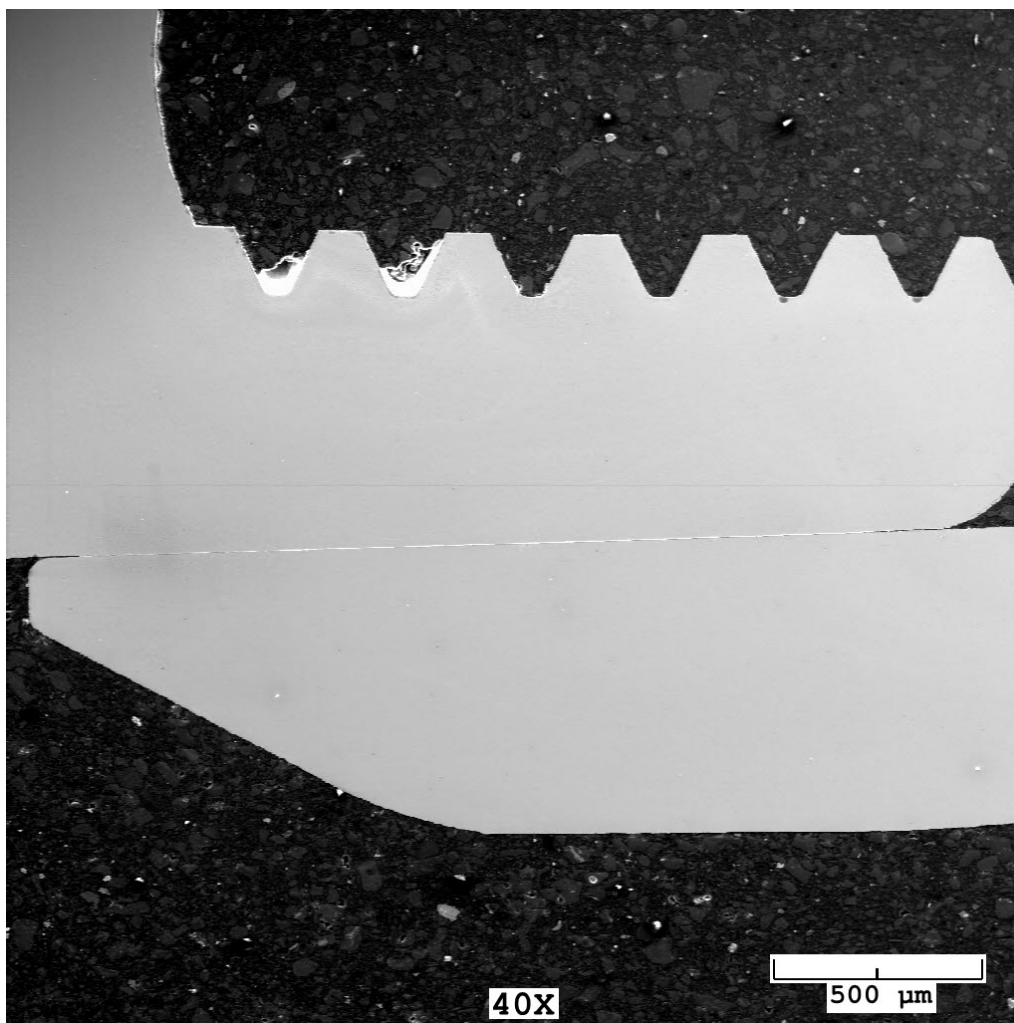
The dental implant and abutment were in intimate contact (no gap was detected) in continuous areas along the interface length.

Figure 2, Implant / abutment interface as viewed with a SEM at 40X magnification

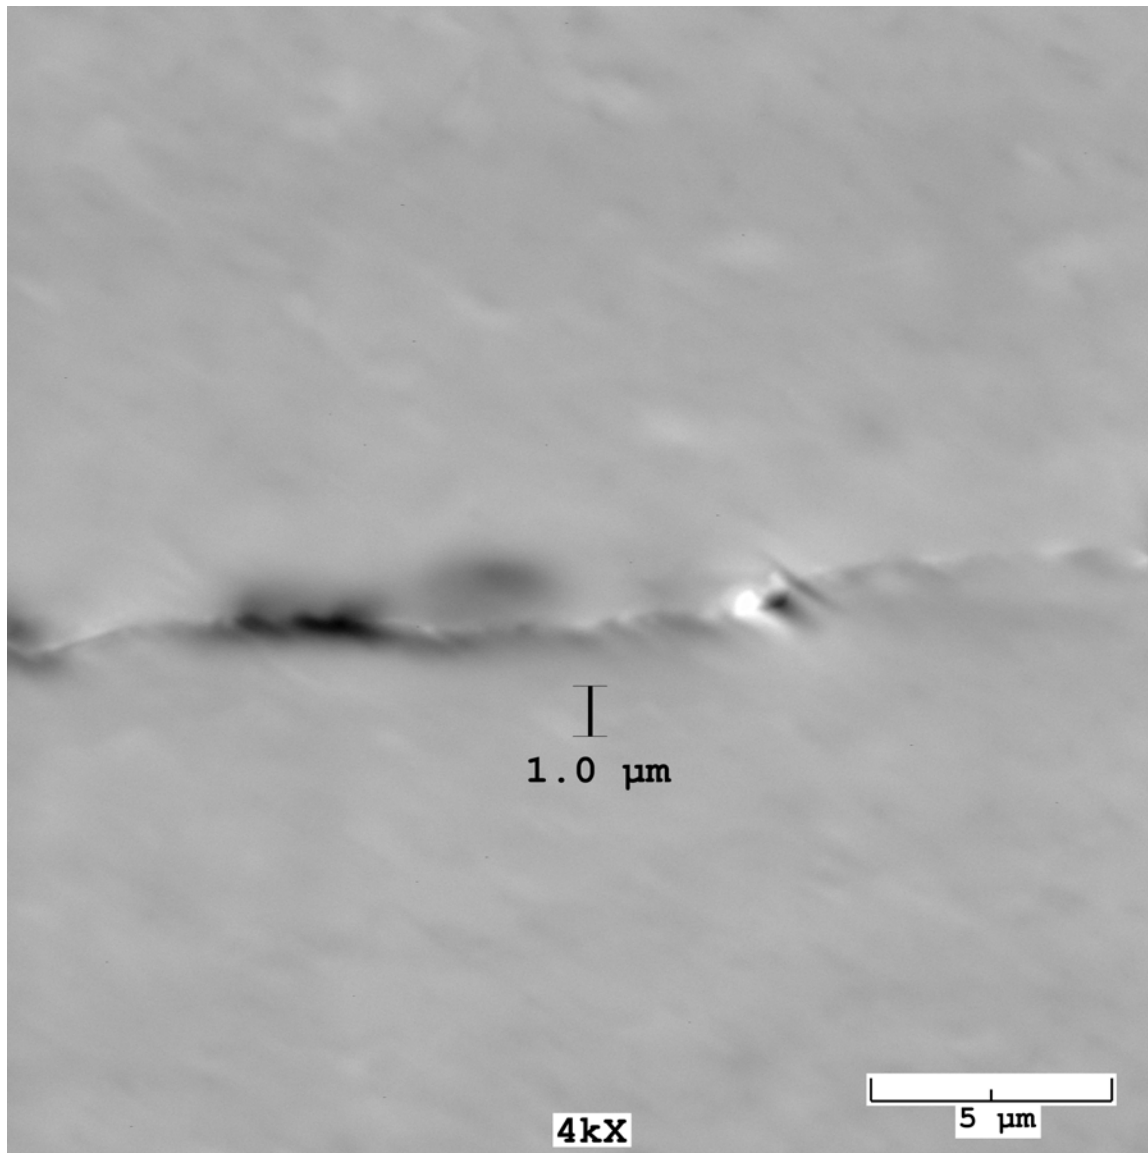
Figure 3, A section of the Implant / abutment interface as viewed with a SEM at 4000X magnification. The dark areas are discolorations from the polishing process.
